SURVEY STATEMENT

Name of vessel: **MSC RITA**
Owner: **Compania Naviera Rita S.A.**
IMO Number: **9289116**

Survey station: **Miami**
Place of survey: **Charleston, South Carolina(USA)**
Survey started: **2022-10-29**
Survey completed: **2022-11-07**
Lead surveyor: **Woods, Daniel**
Surveyor:

Contact damage

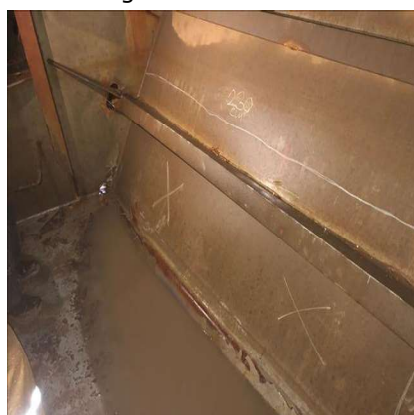
#2S WBT @ FR 114 and approx. 15M above baseline observed from cargo berth to be scraped and indented with punctured opening of approx 600mm x 400mm. Overall indented area extends forward and aft of FR 114 and structural framing appeared to be affected. (Shell plating 15.5mm AH according to shell expansion dwg)

- side shell indented fwd of FR 114, @2M x 1.5M
- side longitudinal distorted over 2.3M length
- 2nd platform buckled fwd of FR 114, 2.5M x up to 600mm
- side shell indented aft of FR 114, 2M x 750mm
- 2nd platform buckled 2.5M x up to 600mm aft of FR 114
- side shell indented below 2nd platform aft of FR 114, 3.2M x 1.5M
- side longitudinal distorted over 3M length

#2S, FR 114 aft - shell indent & 2nd platform buckled

#2S WBT temporary repair: Stbd side shell plating in way of FR 114 puncture temporarily repaired by welded insert (3 pcs), approx. overall size 2050 x 1800 x 15.9mm. Material, welding procedure and welder certs accepted. Insert fit-up, and vacuum box of completed welding verified with satisfactory results. Two longitudinals of 2000mm length were cropped and renewed as indicated in photos.

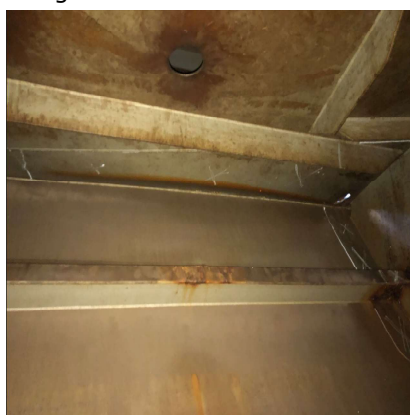
#2S, FR 114 fwd - below 2nd platform

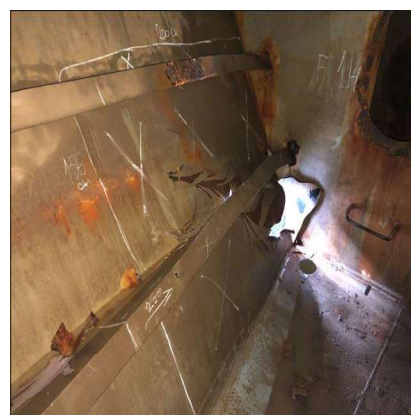
#2S, FR 114 fwd - shell indent & puncture, 2nd platform buckled

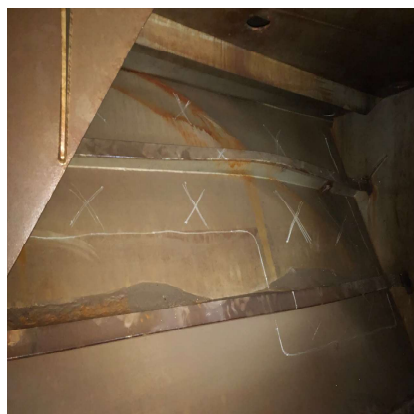
#2S, FR 114 fwd below 2nd platform
- shell indent & structural framing damage

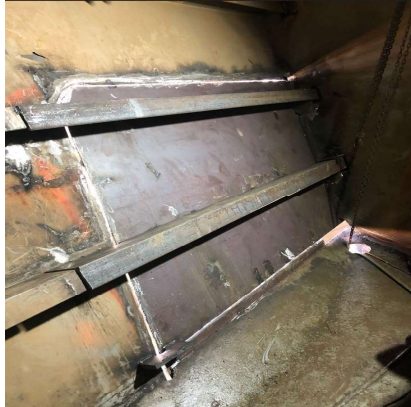
#2S - Insert fit-up fwd of FR 114, above 2nd platform

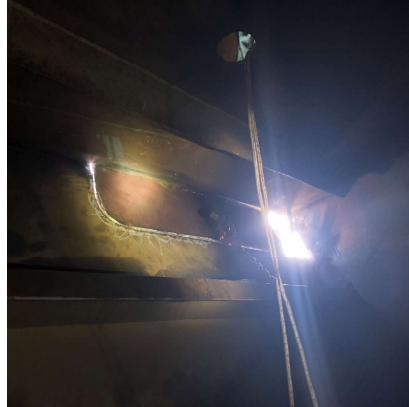
#2S - Insert fit-up fwd of FR 114, below 2nd platform

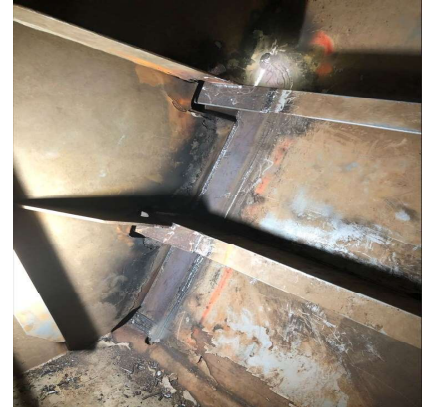
#2S - Insert welding completed aft of FR 114, above 2nd platform

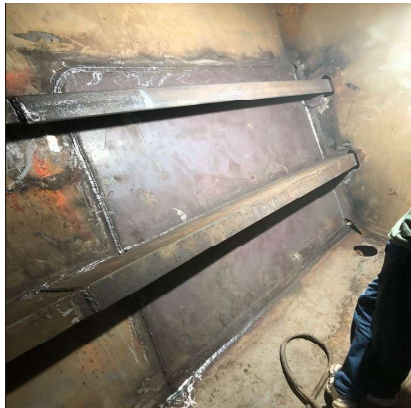
#2S - Insert welding completed fwd of FR 114, above 2nd platform

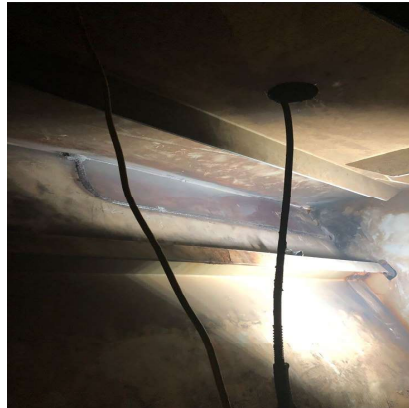
#2S - Insert welding completed fwd of FR 114, below 2nd platform

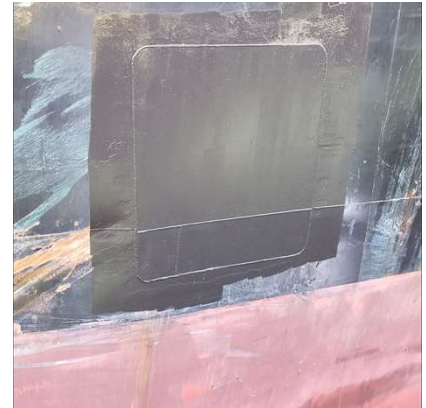
#2S - Side shell insert coated

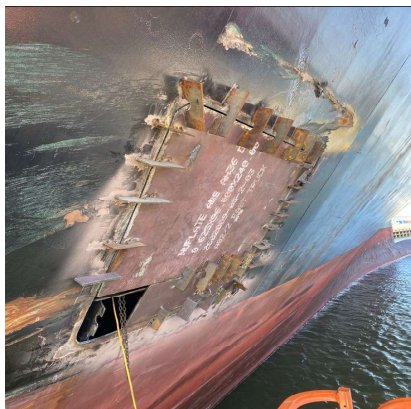
#2S - side shell insert fit-up in way of FR 114 (photo 1)

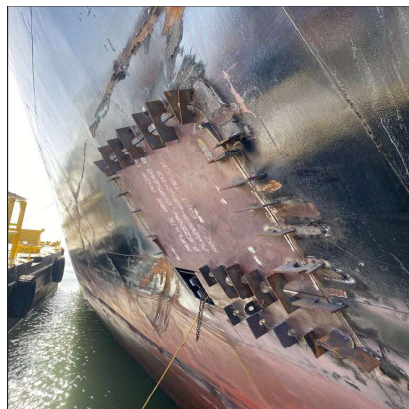
#2S - side shell insert fit-up in way of FR 114 (photo 2)

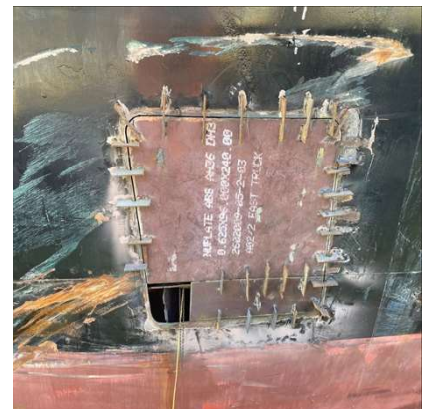
#2S - side shell insert fit-up in way of FR 114 (photo 3)

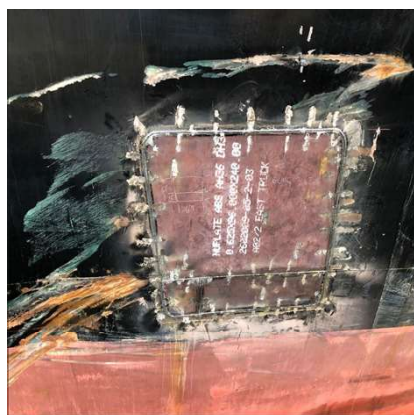
#2S - Side shell insert welding complete

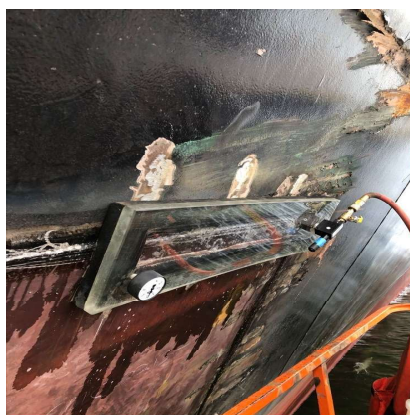
Vacuum box (photo 1)

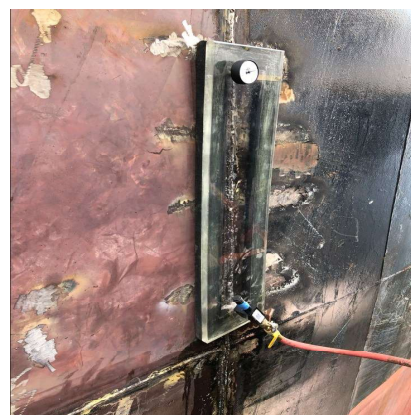
Vacuum box (photo 2)

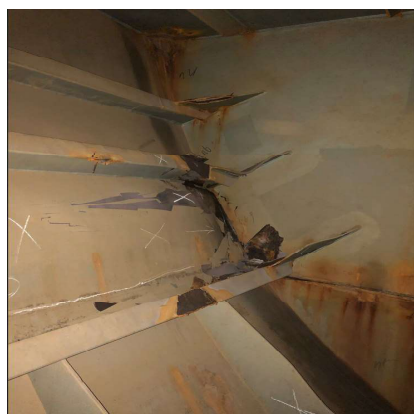
- side shell indented between FR 12 and 13, 3M x 800mm
- longitudinal ends distorted at FR 12 and 13
- connecting brackets and stiffeners buckled or fractured as noted in photos
- side shell indented between FR 13 and 14, 2.5M x 800mm
- longitudinal end distorted at FR 13
- swash bulkhead buckled at FR 13, 1.5M x 600mm

#8S, FR 12-13 - shell indent, structural framing damages (looking aft, photo 1)

#8S WBT temporary repair: Buckled section of FR 13 has been repaired by welded insert (5 pcs), approx. overall size 2100 x 1200 x 12mm. Material, welding procedure and welder certs accepted. Insert fit-ups and welding has been satisfactorily completed. Three longitudinals of 200mm length in way of FR 13 were cropped and renewed, and bracket connections restored as indicated in photos.

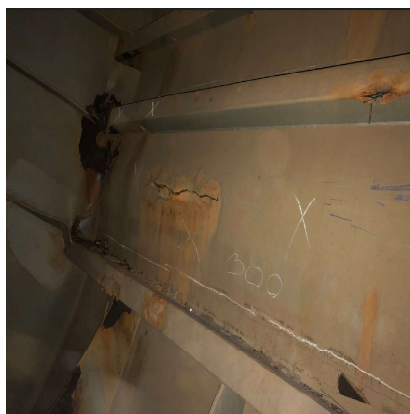
#8S, FR 12-13 - shell indent, structural framing damages (looking fwd)

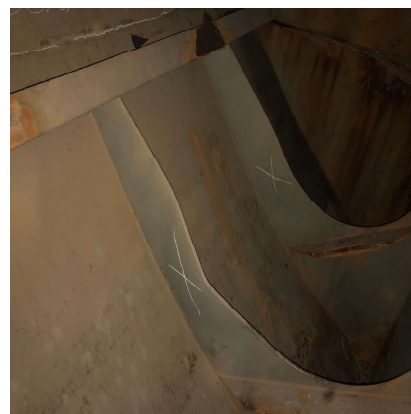
#8S, FR 12-13 - structural framing damages (looking aft)

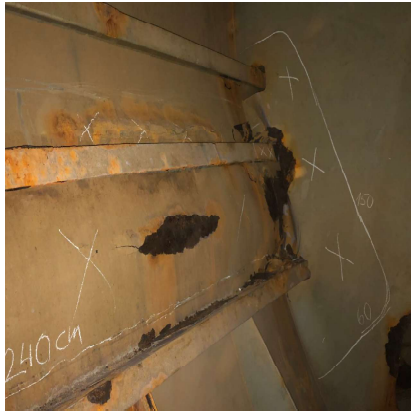
#8S, FR 13-14 - shell indent, structural framing damages (looking aft)

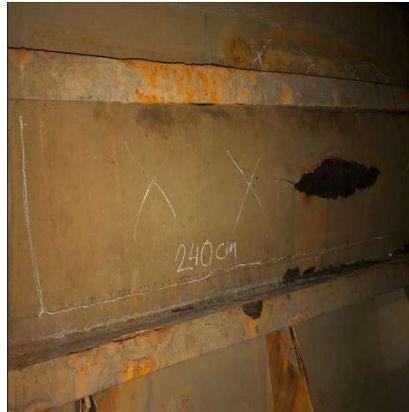
#8S, FR 13-14 - shell indent, structural framing damages (looking aft, photo 2)

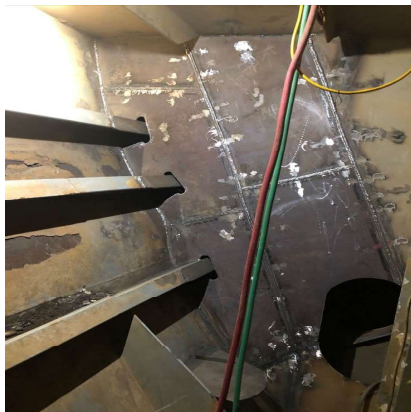
#8S - FR 13 web completed welding, looking aft

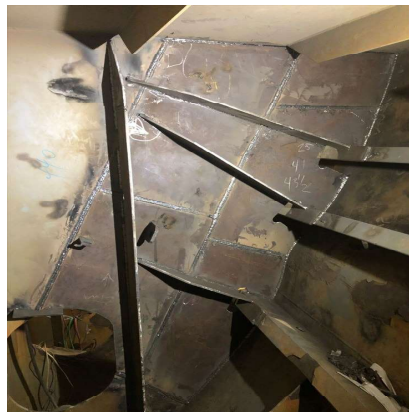
#8S - FR 13 web completed welding, looking fwd

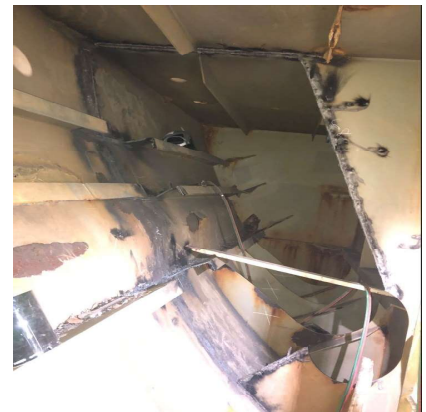
#8S - FR 13 web cut-out

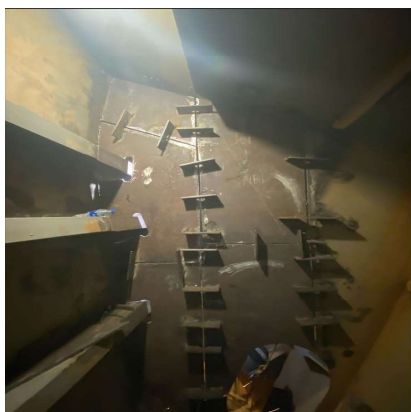
#8S - FR 13 web insert fit-ups
